## Appendix B: photographs of test setup

## Appendix C: photographs of EUT

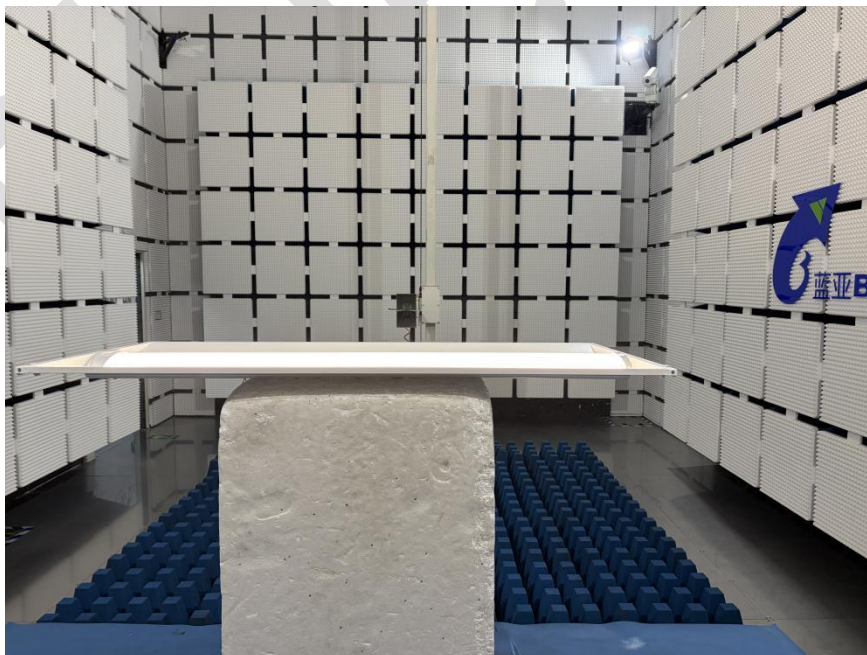
Radiated Emissions (above 1GHz)

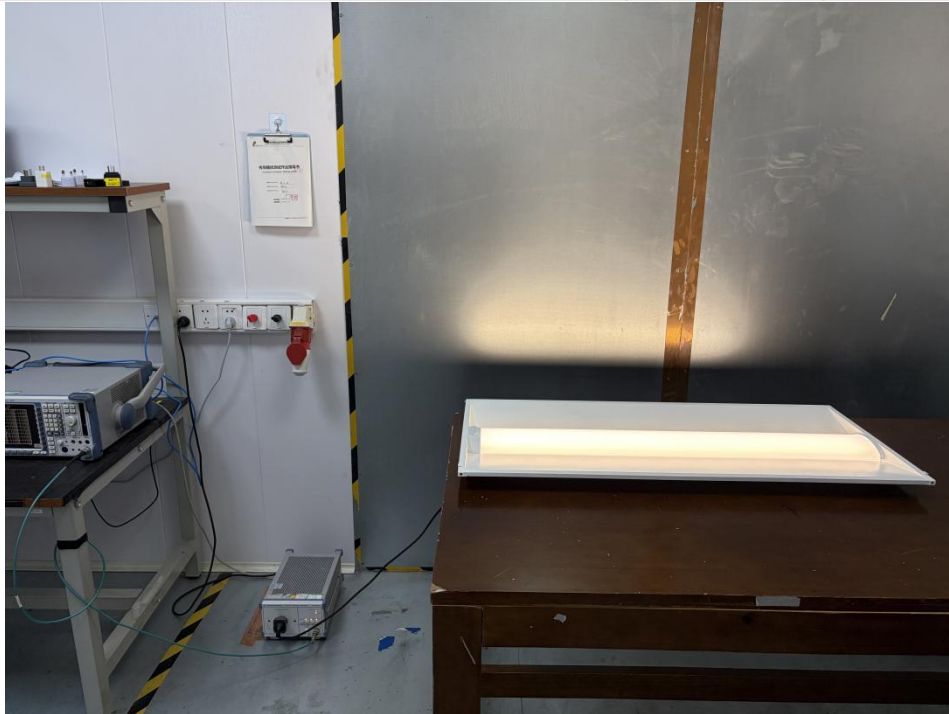
Conducted emissions at AC power line (150kHz-30MHz)
