### **APPENDIX3: Photographs of test setup**

#### **Radiated Spurious Emission**

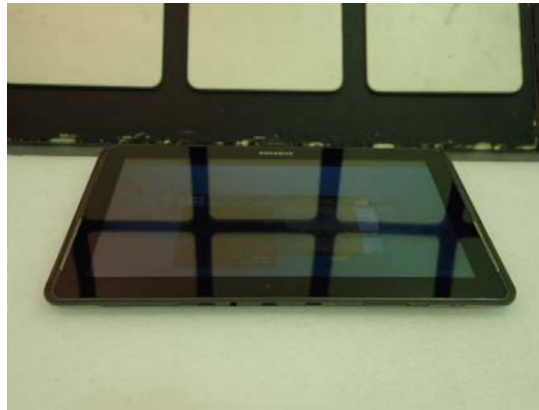
**X-axis**

**Worst Case Position**

Band 4 :Horizontal: Y-axis/ Vertical:Z-axis  
Band 17 :Horizontal: X-axis/ Vertical:Y-axis
