## ***APPENDIX C – PHOTOGRAPHS OF TEST SET-UP***

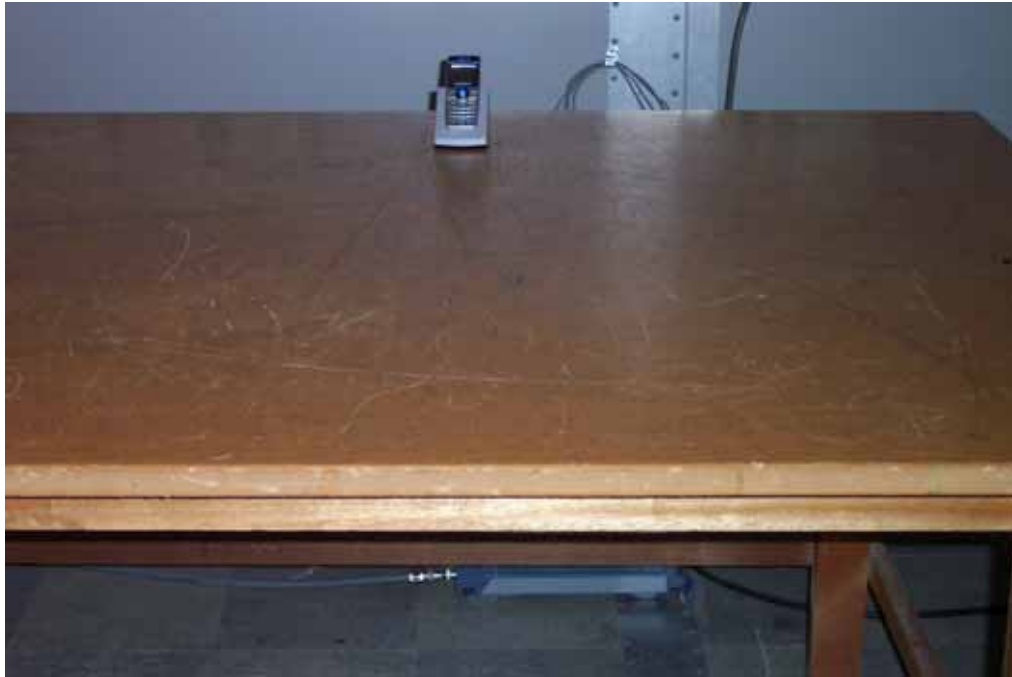
- **Conducted Test Picture(Front)**

The **Conducted Test Picture** and **Radiated Test Picture** and show the worst-case configuration and cable placement.

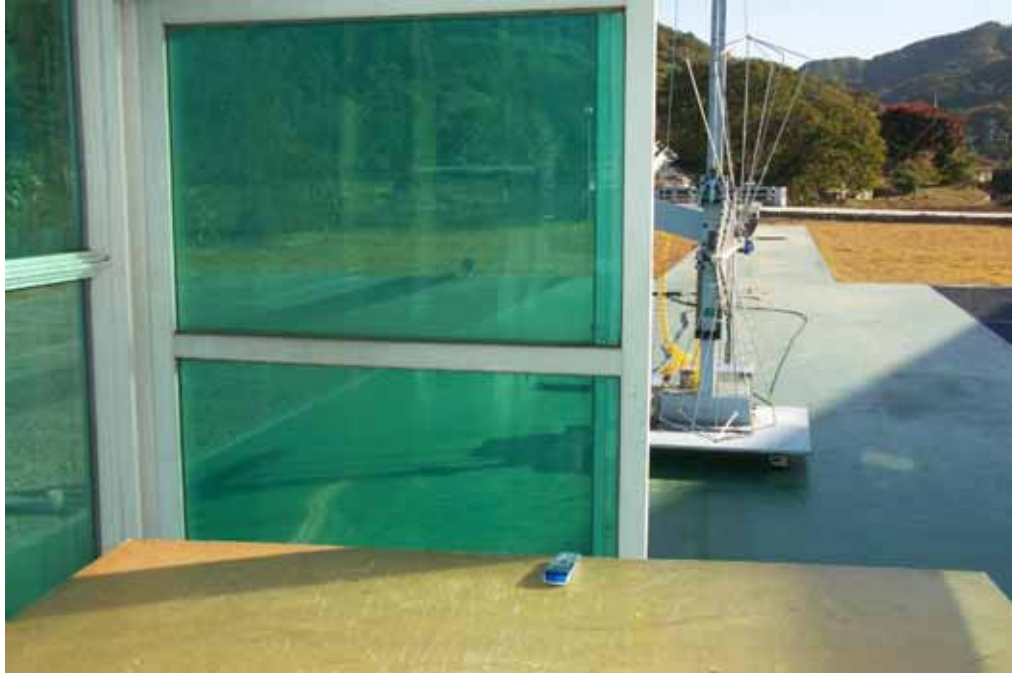
- **Radiated Test Picture(Front)**

The **Radiated Test Picture** show the worst-case configuration from the X-azimuth.

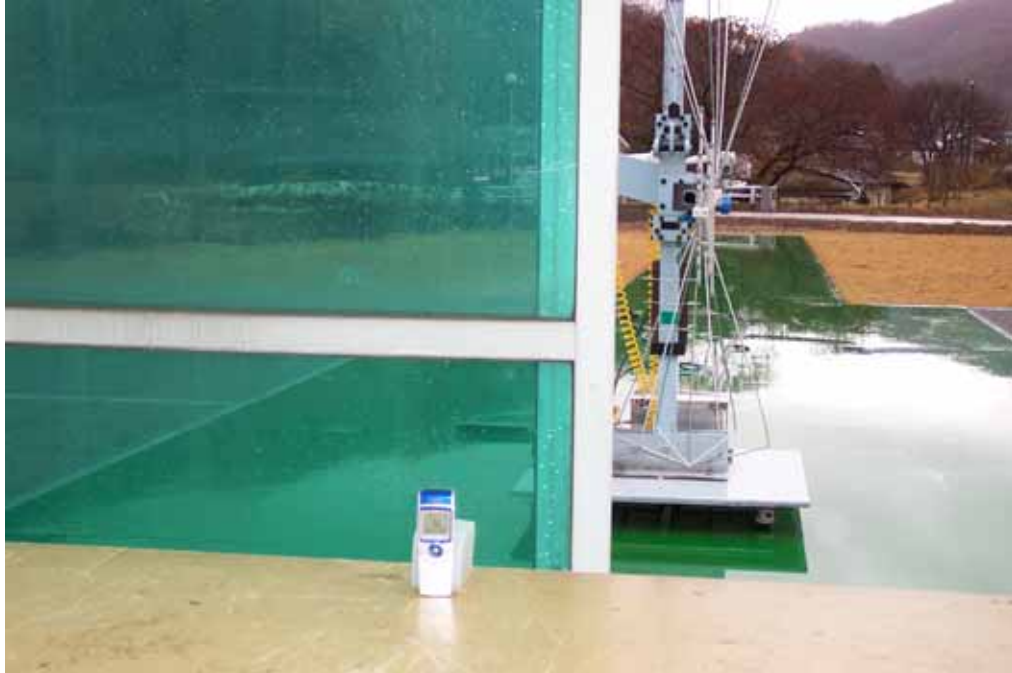
- **Radiated Test Picture(Front)**

The **Radiated Test Picture** show the worst-case configuration from the Y-azimuth.

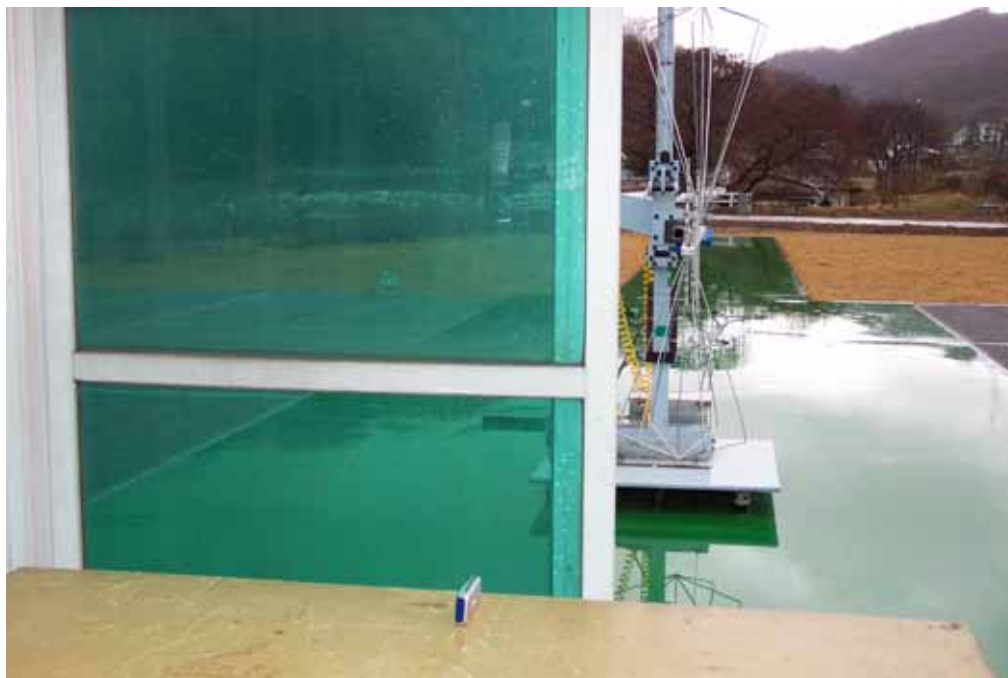
- **Radiated Test Picture(Front)**

The **Radiated Test Picture** show the worst-case configuration from the Z-azimuth.
