## FCC SAR Test Report

### <Photographs of SAR Setup>

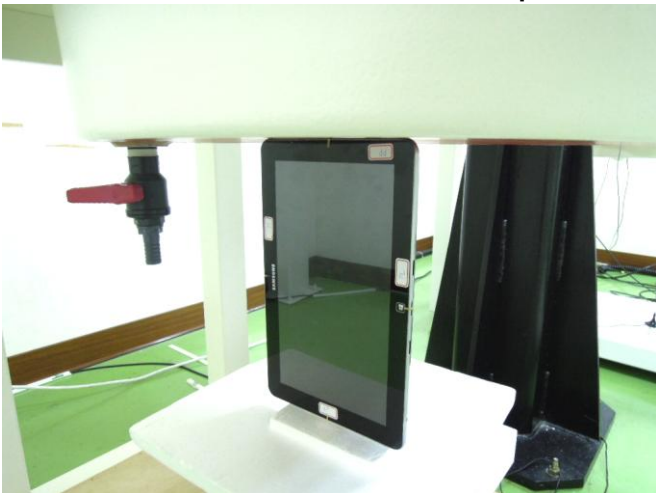
**Primary Portrait with 0 cm Gap**

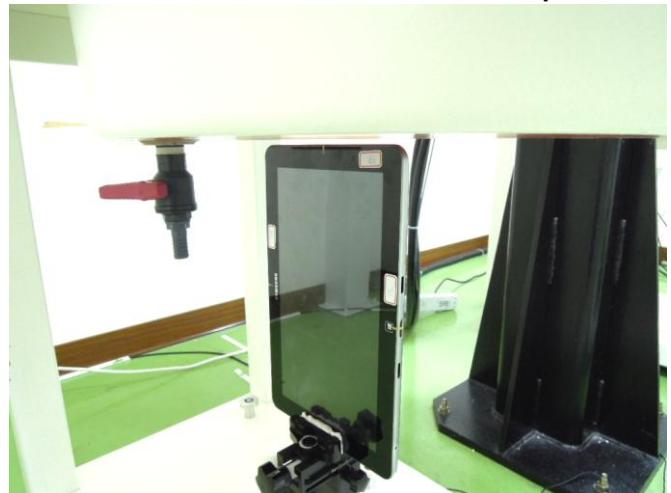
**Primary Portrait with 0.9 cm Gap**

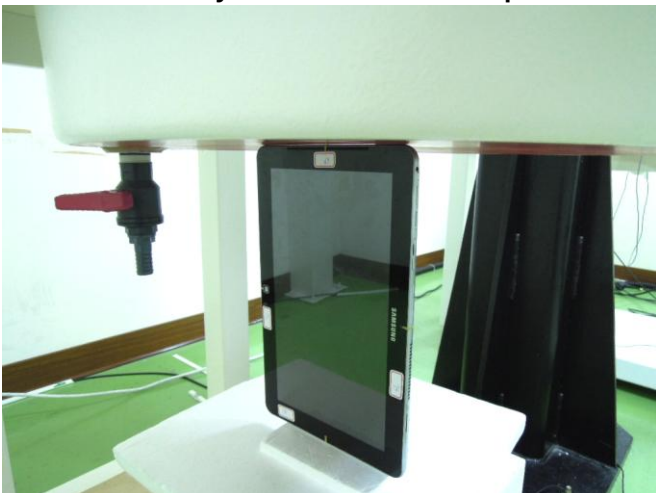
**Secondary Portrait with 0 cm Gap**

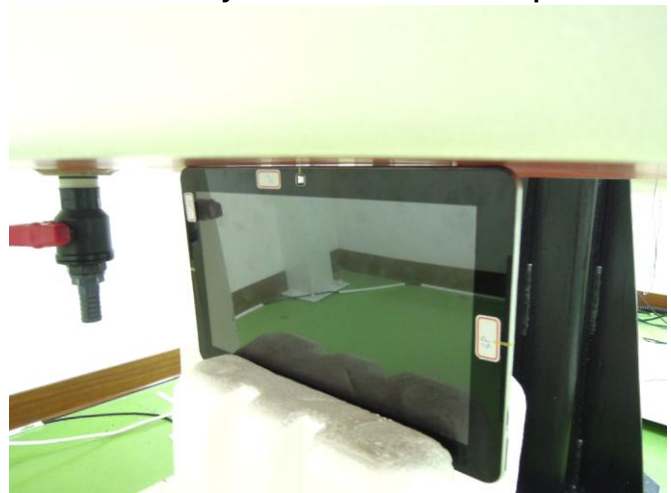
**Primary Landscape with 0 cm Gap**

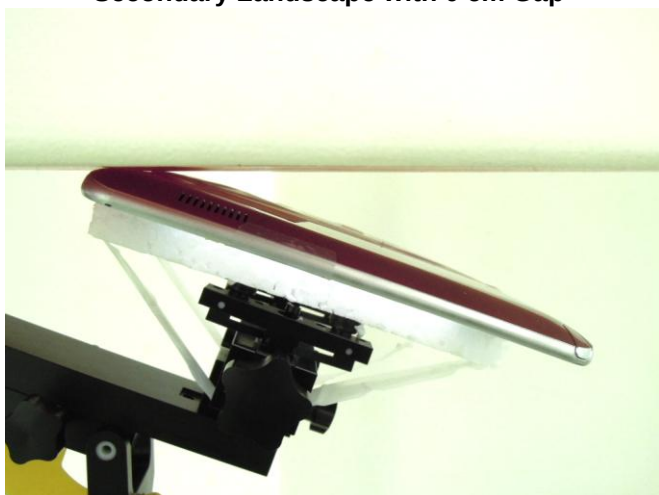
**Rear Face of EUT with 0 cm Gap  
(Top Edge/Left Rear Corner at 20 degree)**
