## 5.2.9 30\_S\_90M\_NTNV

## n77a\_30kHz\_SISO\_NTNV\_90MHz\_DFT-s-OFDM PI/2 BPSK 3745.02MHz\_Edge\_1RB\_Left\_Ant1

## 5.2.10 30\_S\_100M\_NTNV

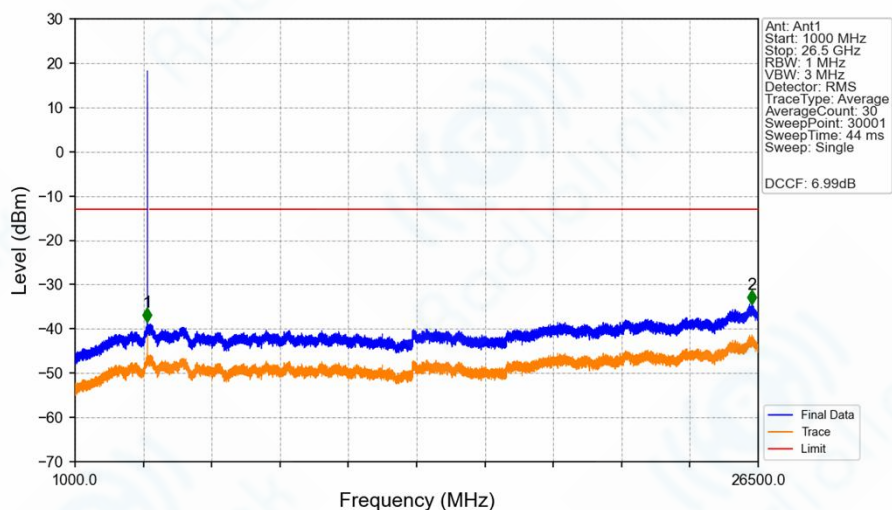
| Start (MHz) | Stop (MHz) | RBW (MHz) | Method | Marker No. | Freq (MHz) | Level (dBm) | Limit (dBm) | Result |
|---|---|---|---|---|---|---|---|---|
| 1000 | 3695.02 | 1 | / | 1 | 3691.950 | -38.42 | -13 | Pass |
| 3795.02 | 26500 | 1 | / | 2 | 26267.950 | -34.37 | -13 | Pass |

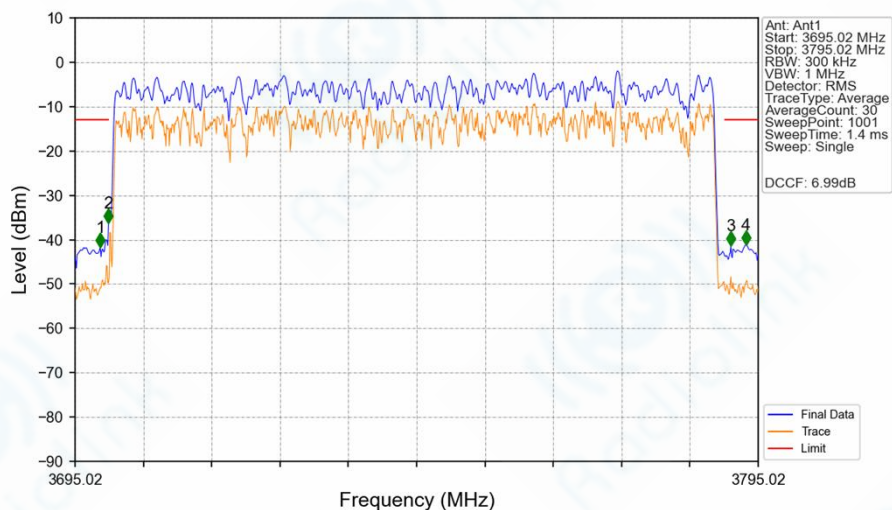
## n77a\_30kHz\_SISO\_NTNV\_90MHz\_DFT-s-OFDM PI/2 BPSK 3745.02MHz\_Outer\_Full\_Ant1

| Start (MHz) | Stop (MHz) | RBW (MHz) | Method | Marker No. | Freq (MHz) | Level (dBm) | Limit (dBm) | Result |
|---|---|---|---|---|---|---|---|---|
| 3695.02 | 3699.02 | 0.5 | CHP | 1 | 3698.720 | -41.68 | -13 | Pass |
| 3699.02 | 3700.02 | 0.35 | CHP | 2 | 3699.920 | -36.15 | -13 | Pass |
| 3790.02 | 3791.02 | 0.35 | CHP | 3 | 3791.020 | -41.37 | -13 | Pass |
| 3791.02 | 3795.02 | 0.5 | CHP | 4 | 3793.220 | -41.20 | -13 | Pass |

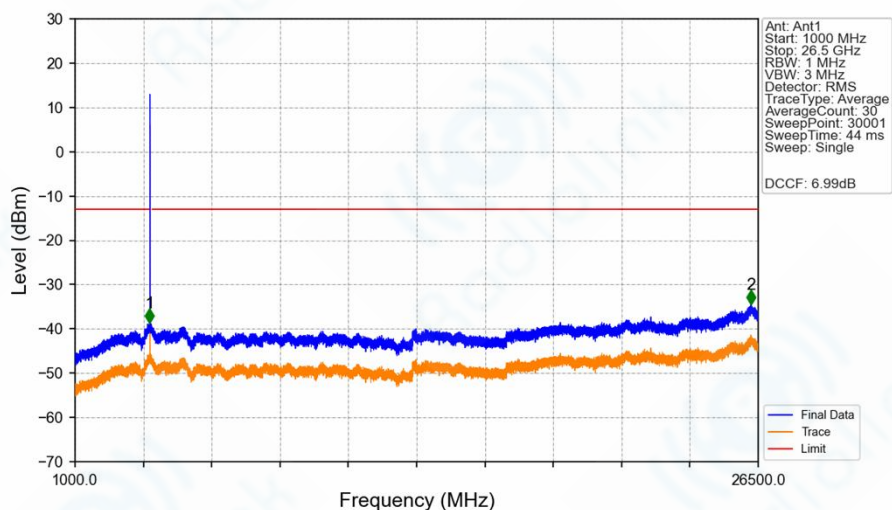
## n77a\_30kHz\_SISO\_NTNV\_90MHz\_DFT-s-OFDM\_PI/2\_BPSK\_3840MHz\_Edge\_1RB\_Left\_Ant1

| Start (MHz) | Stop (MHz) | RBW (MHz) | Method | Marker No. | Freq (MHz) | Level (dBm) | Limit (dBm) | Result |
|---|---|---|---|---|---|---|---|---|
| 1000 | 3790 | 1 | / | 1 | 3781.200 | -38.61 | -13 | Pass |
| 3890 | 26500 | 1 | / | 2 | 26225.450 | -34.37 | -13 | Pass |

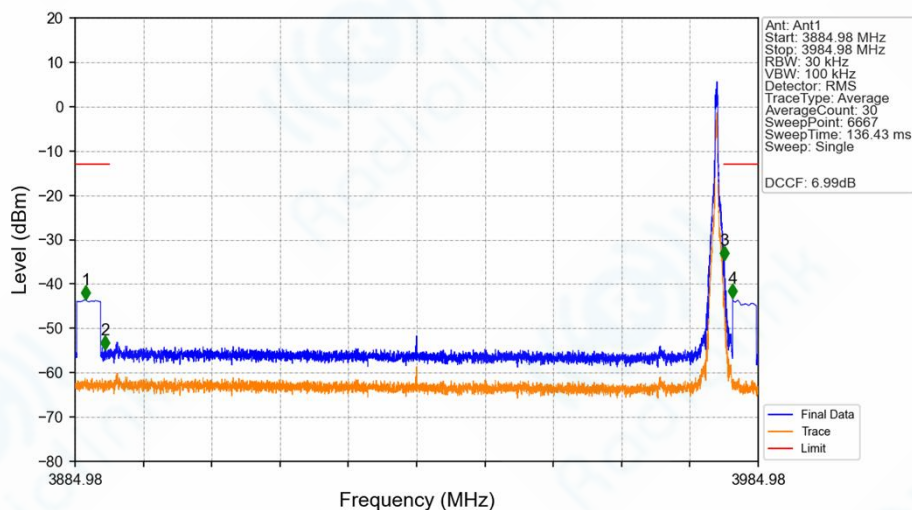
## n77a\_30kHz\_SISO\_NTNV\_90MHz\_DFT-s-OFDM\_PI/2\_BPSK\_3934.98MHz\_Edge\_1RB\_Right\_Ant1

| Start (MHz) | Stop (MHz) | RBW (MHz) | Method | Marker No. | Freq (MHz) | Level (dBm) | Limit (dBm) | Result |
|---|---|---|---|---|---|---|---|---|
| 3884.98 | 3888.98 | 0.5 | CHP | 1 | 3886.540 | -43.54 | -13 | Pass |
| 3888.98 | 3889.98 | 0.03 | / | 2 | 3889.360 | -54.78 | -13 | Pass |
| 3979.98 | 3980.98 | 0.03 | / | 3 | 3980.000 | -34.65 | -13 | Pass |
| 3980.98 | 3984.98 | 0.5 | CHP | 4 | 3981.245 | -43.19 | -13 | Pass |

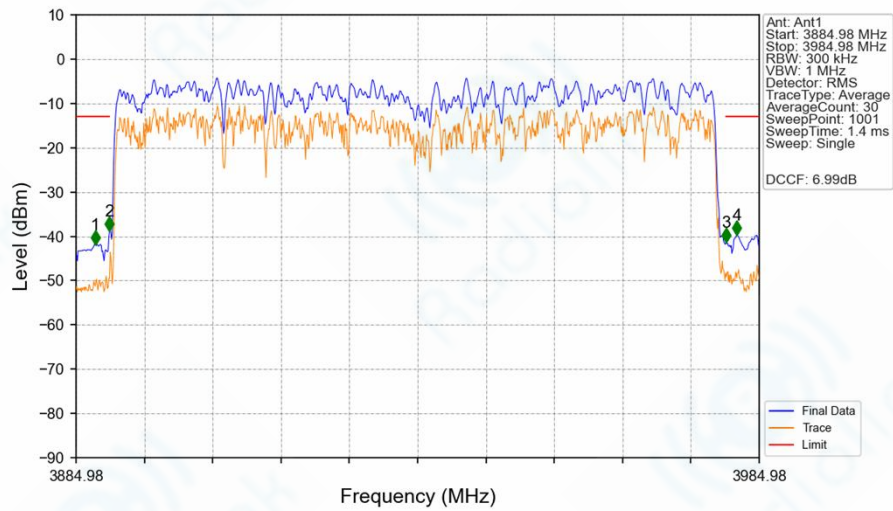
## n77a 30kHz\_SISO\_NTNV\_90MHz\_DFT-s-OFDM PI/2 BPSK\_3934.98MHz\_Outer\_Full\_Ant1

| Start (MHz) | Stop (MHz) | RBW (MHz) | Method | Marker No. | Freq (MHz) | Level (dBm) | Limit (dBm) | Result |
|---|---|---|---|---|---|---|---|---|
| 3884.98 | 3888.98 | 0.5 | CHP | 1 | 3887.780 | -41.82 | -13 | Pass |
| 3888.98 | 3889.98 | 0.35 | CHP | 2 | 3889.880 | -38.80 | -13 | Pass |
| 3979.98 | 3980.98 | 0.35 | CHP | 3 | 3980.180 | -41.30 | -13 | Pass |
| 3980.98 | 3984.98 | 0.5 | CHP | 4 | 3981.680 | -39.68 | -13 | Pass |

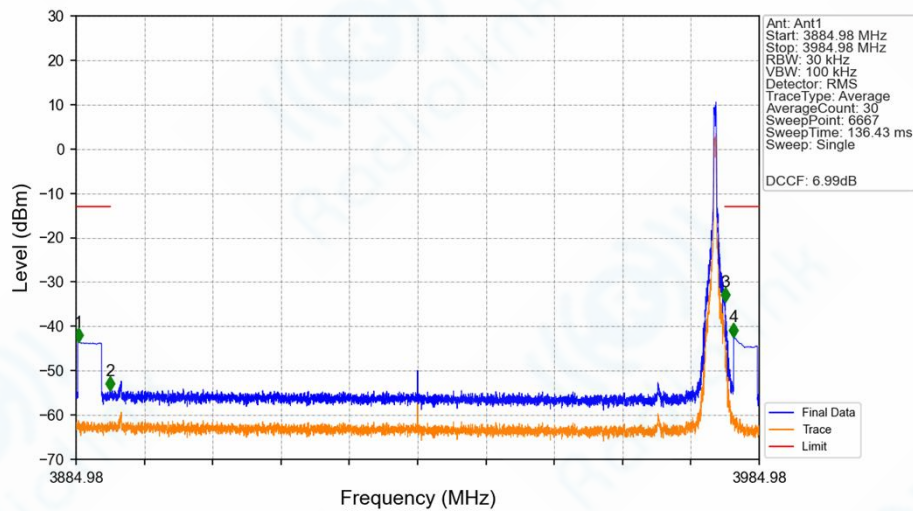
## n77a 30kHz\_SISO\_NTNV\_90MHz\_DFT-s-OFDM PI/2 BPSK\_3934.98MHz\_Inner\_1RB\_Right\_Ant1

| Start (MHz) | Stop (MHz) | RBW (MHz) | Method | Marker No. | Freq (MHz) | Level (dBm) | Limit (dBm) | Result |
|---|---|---|---|---|---|---|---|---|
| 3884.98 | 3888.98 | 0.5 | CHP | 1 | 3885.280 | -43.48 | -13 | Pass |
| 3888.98 | 3889.98 | 0.03 | / | 2 | 3889.960 | -54.43 | -13 | Pass |
| 3979.98 | 3980.98 | 0.03 | / | 3 | 3979.985 | -34.37 | -13 | Pass |
| 3980.98 | 3984.98 | 0.5 | CHP | 4 | 3981.245 | -42.35 | -13 | Pass |

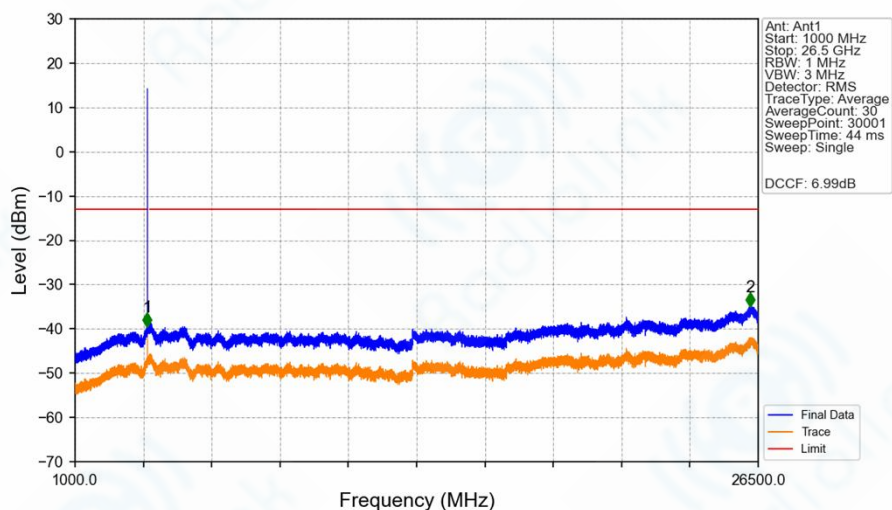
## n77a\_30kHz\_SISO\_NTNV\_90MHz\_DFT-s-OFDM\_QPSK\_3745.02MHz\_Edge\_1RB\_Left\_Ant1

| Start (MHz) | Stop (MHz) | RBW (MHz) | Method | Marker No. | Freq (MHz) | Level (dBm) | Limit (dBm) | Result |
|---|---|---|---|---|---|---|---|---|
| 1000 | 3695.02 | 1 | / | 1 | 3686.000 | -39.57 | -13 | Pass |
| 3795.02 | 26500 | 1 | / | 2 | 26209.300 | -34.98 | -13 | Pass |

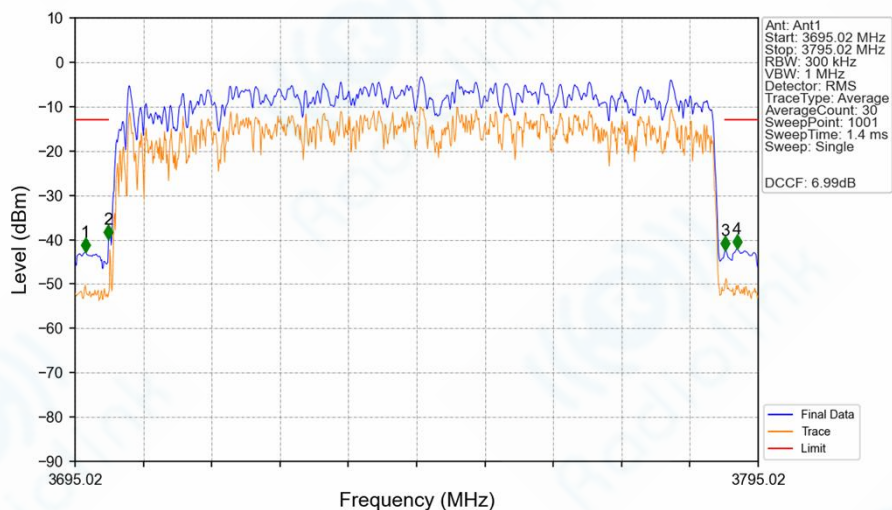
## n77a\_30kHz\_SISO\_NTNV\_90MHz\_DFT-s-OFDM\_QPSK\_3745.02MHz\_Outer\_Full\_Ant1

| Start (MHz) | Stop (MHz) | RBW (MHz) | Method | Marker No. | Freq (MHz) | Level (dBm) | Limit (dBm) | Result |
|---|---|---|---|---|---|---|---|---|
| 3695.02 | 3699.02 | 0.5 | CHP | 1 | 3696.520 | -42.83 | -13 | Pass |
| 3699.02 | 3700.02 | 0.35 | CHP | 2 | 3699.920 | -39.81 | -13 | Pass |
| 3790.02 | 3791.02 | 0.35 | CHP | 3 | 3790.220 | -42.32 | -13 | Pass |
| 3791.02 | 3795.02 | 0.5 | CHP | 4 | 3791.920 | -42.08 | -13 | Pass |

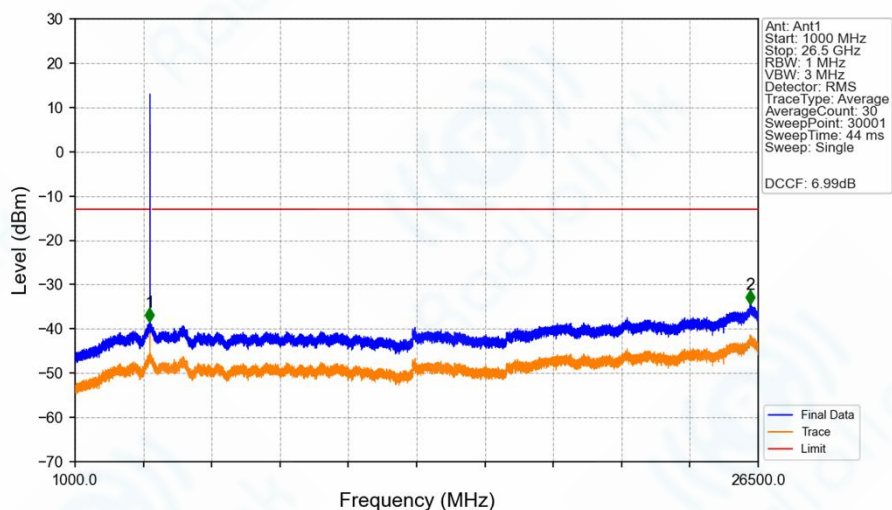
## n77a\_30kHz\_SISO\_NTNV\_90MHz\_DFT-s-OFDM\_QPSK\_3840MHz\_Edge\_1RB\_Left\_Ant1

| Start (MHz) | Stop (MHz) | RBW (MHz) | Method | Marker No. | Freq (MHz) | Level (dBm) | Limit (dBm) | Result |
|---|---|---|---|---|---|---|---|---|
| 1000 | 3790 | 1 | / | 1 | 3784.600 | -38.52 | -13 | Pass |
| 3890 | 26500 | 1 | / | 2 | 26193.150 | -34.35 | -13 | Pass |

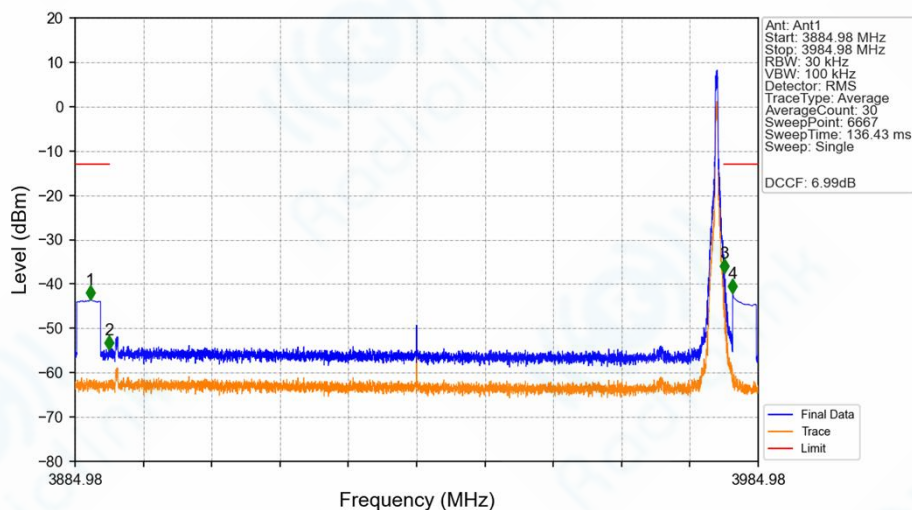
## n77a\_30kHz\_SISO\_NTNV\_90MHz\_DFT-s-OFDM\_QPSK\_3934.98MHz\_Edge\_1RB\_Right\_Ant1

| Start (MHz) | Stop (MHz) | RBW (MHz) | Method | Marker No. | Freq (MHz) | Level (dBm) | Limit (dBm) | Result |
|---|---|---|---|---|---|---|---|---|
| 3884.98 | 3888.98 | 0.5 | CHP | 1 | 3887.200 | -43.58 | -13 | Pass |
| 3888.98 | 3889.98 | 0.03 | / | 2 | 3889.930 | -54.75 | -13 | Pass |
| 3979.98 | 3980.98 | 0.03 | / | 3 | 3980.045 | -37.54 | -13 | Pass |
| 3980.98 | 3984.98 | 0.5 | CHP | 4 | 3981.245 | -42.06 | -13 | Pass |

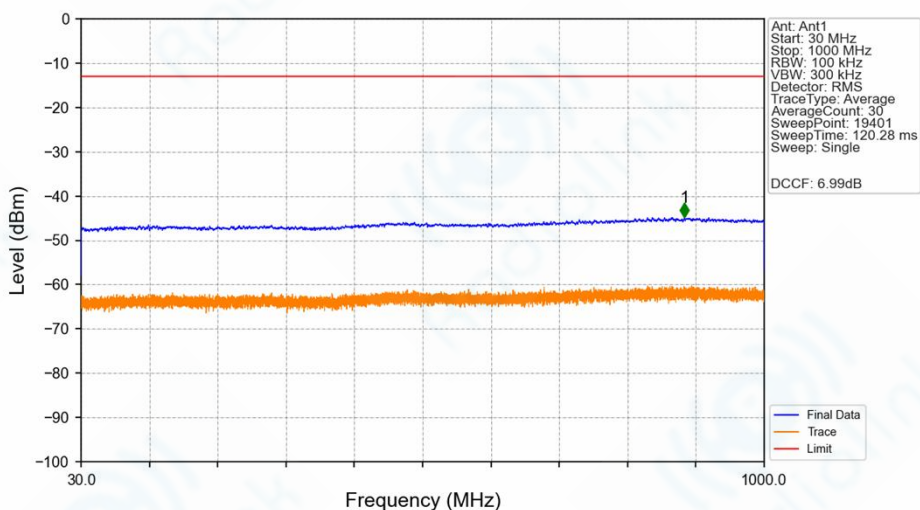
n77a\_30kHz\_SISO\_NTNV\_90MHz\_DFT-s-OFDM\_QPSK\_3934.98MHz\_Edge\_1RB\_Right\_Ant1

| Start (MHz) | Stop (MHz) | RBW (MHz) | Method | Marker No. | Freq (MHz) | Level (dBm) | Limit (dBm) | Result |
|---|---|---|---|---|---|---|---|---|
| 30 | 1000 | 1 | CHP | 1 | 886.950 | -44.75 | -13 | Pass |

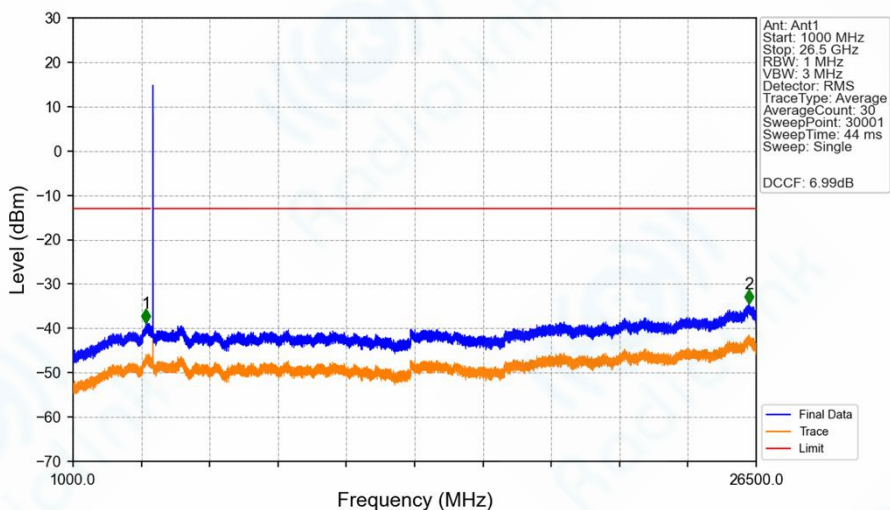
n77a\_30kHz\_SISO\_NTNV\_90MHz\_DFT-s-OFDM\_QPSK\_3934.98MHz\_Edge\_1RB\_Right\_Ant1

| Start (MHz) | Stop (MHz) | RBW (MHz) | Method | Marker No. | Freq (MHz) | Level (dBm) | Limit (dBm) | Result |
|---|---|---|---|---|---|---|---|---|
| 1000 | 3884.98 | 1 | / | 1 | 3723.400 | -38.80 | -13 | Pass |
| 3984.98 | 26500 | 1 | / | 2 | 26224.600 | -34.45 | -13 | Pass |

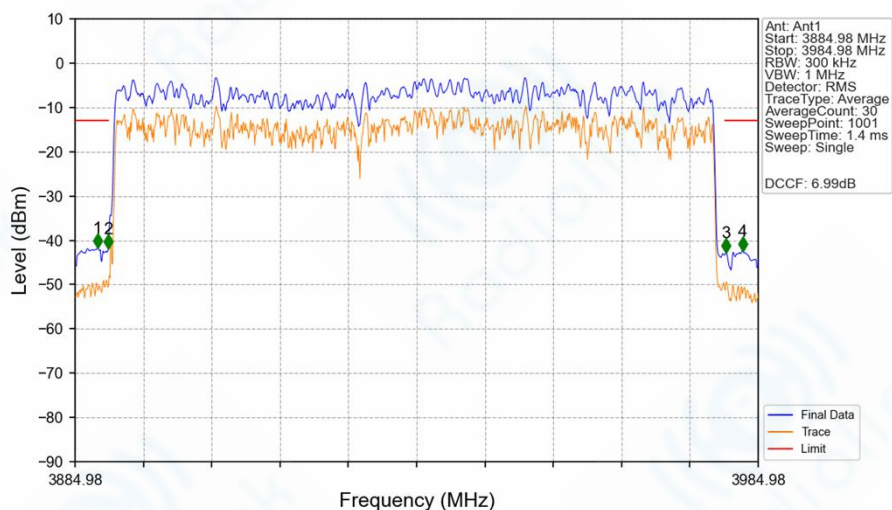
## n77a\_30kHz\_SISO\_NTNV\_90MHz\_DFT-s-OFDM\_QPSK\_3934.98MHz\_Outer\_Full\_Ant1

| Start (MHz) | Stop (MHz) | RBW (MHz) | Method | Marker No. | Freq (MHz) | Level (dBm) | Limit (dBm) | Result |
|---|---|---|---|---|---|---|---|---|
| 3884.98 | 3888.98 | 0.5 | CHP | 1 | 3888.280 | -41.76 | -13 | Pass |
| 3888.98 | 3889.98 | 0.35 | CHP | 2 | 3889.880 | -41.92 | -13 | Pass |
| 3979.98 | 3980.98 | 0.35 | CHP | 3 | 3980.280 | -42.83 | -13 | Pass |
| 3980.98 | 3984.98 | 0.5 | CHP | 4 | 3982.680 | -42.33 | -13 | Pass |

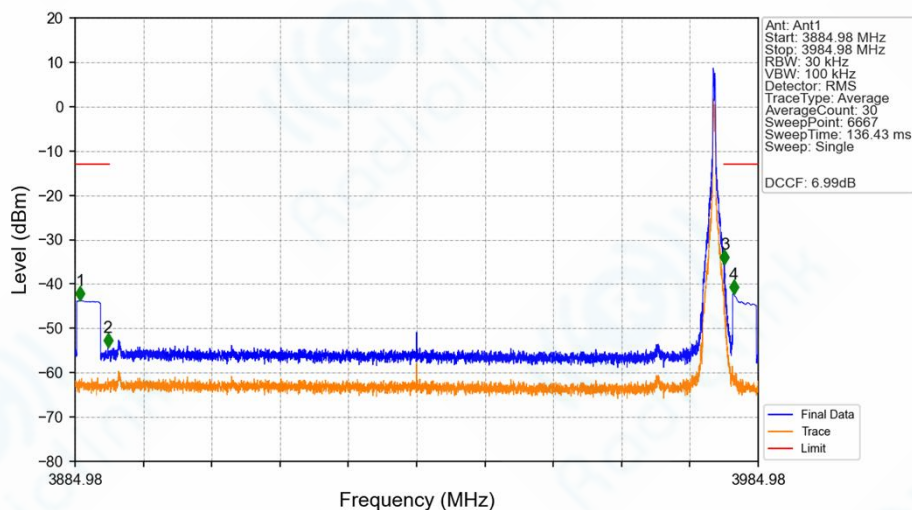
## n77a\_30kHz\_SISO\_NTNV\_90MHz\_DFT-s-OFDM\_QPSK\_3934.98MHz\_Inner\_1RB\_Right\_Ant1

| Start (MHz) | Stop (MHz) | RBW (MHz) | Method | Marker No. | Freq (MHz) | Level (dBm) | Limit (dBm) | Result |
|---|---|---|---|---|---|---|---|---|
| 3884.98 | 3888.98 | 0.5 | CHP | 1 | 3885.715 | -43.66 | -13 | Pass |
| 3888.98 | 3889.98 | 0.03 | / | 2 | 3889.780 | -54.23 | -13 | Pass |
| 3979.98 | 3980.98 | 0.03 | / | 3 | 3980.075 | -35.52 | -13 | Pass |
| 3980.98 | 3984.98 | 0.5 | CHP | 4 | 3981.380 | -42.19 | -13 | Pass |

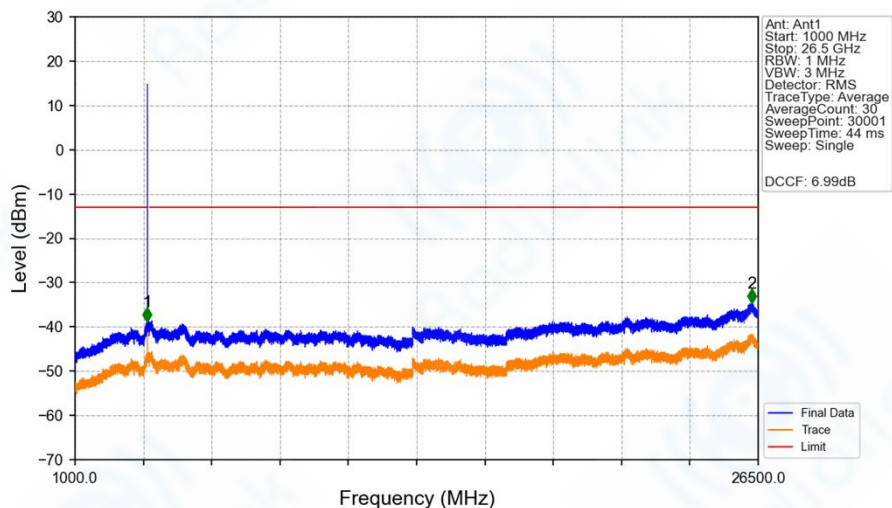
## n77a\_30kHz\_SISO\_NTNV\_90MHz\_CP-OFDM\_QPSK\_3745.02MHz\_Edge\_1RB\_Left\_Ant1

| Start (MHz) | Stop (MHz) | RBW (MHz) | Method | Marker No. | Freq (MHz) | Level (dBm) | Limit (dBm) | Result |
|---|---|---|---|---|---|---|---|---|
| 1000 | 3695.02 | 1 | / | 1 | 3692.800 | -38.87 | -13 | Pass |
| 3795.02 | 26500 | 1 | / | 2 | 26261.150 | -34.59 | -13 | Pass |

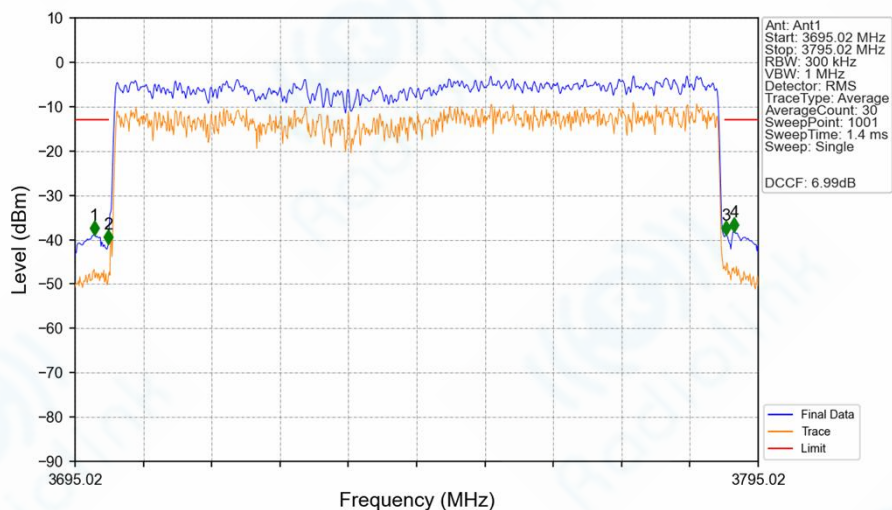
## n77a\_30kHz\_SISO\_NTNV\_90MHz\_CP-OFDM\_QPSK\_3745.02MHz\_Outer\_Full\_Ant1

| Start (MHz) | Stop (MHz) | RBW (MHz) | Method | Marker No. | Freq (MHz) | Level (dBm) | Limit (dBm) | Result |
|---|---|---|---|---|---|---|---|---|
| 3695.02 | 3699.02 | 0.5 | CHP | 1 | 3697.820 | -38.86 | -13 | Pass |
| 3699.02 | 3700.02 | 0.35 | CHP | 2 | 3699.920 | -40.97 | -13 | Pass |
| 3790.02 | 3791.02 | 0.35 | CHP | 3 | 3790.320 | -38.89 | -13 | Pass |
| 3791.02 | 3795.02 | 0.5 | CHP | 4 | 3791.520 | -38.19 | -13 | Pass |

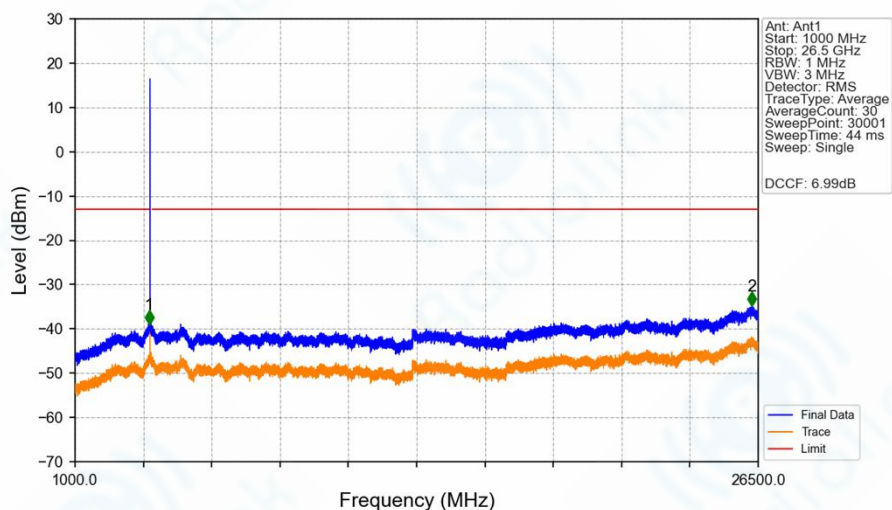
## n77a\_30kHz\_SISO\_NTNV\_90MHz\_CP-OFDM\_QPSK\_3840MHz\_Edge\_1RB\_Left\_Ant1

| Start (MHz) | Stop (MHz) | RBW (MHz) | Method | Marker No. | Freq (MHz) | Level (dBm) | Limit (dBm) | Result |
|---|---|---|---|---|---|---|---|---|
| 1000 | 3790 | 1 | / | 1 | 3758.250 | -38.95 | -13 | Pass |
| 3890 | 26500 | 1 | / | 2 | 26250.100 | -34.74 | -13 | Pass |

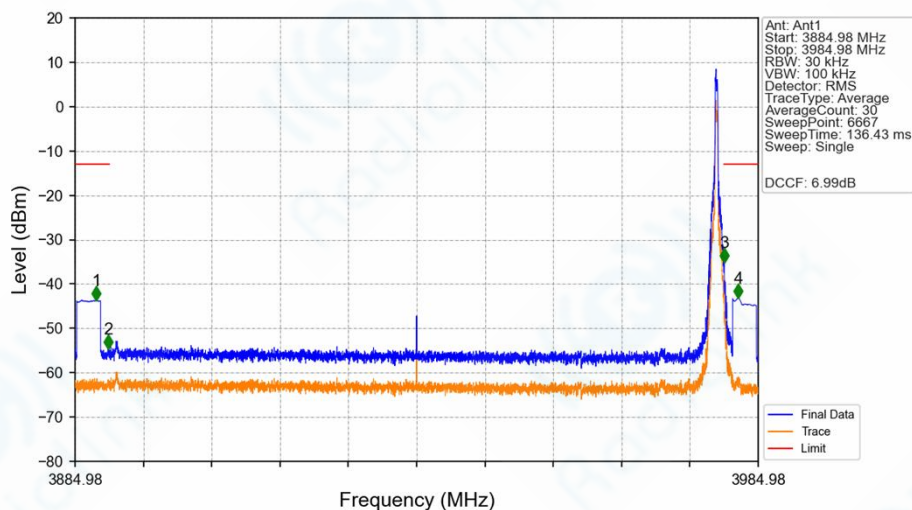
## n77a\_30kHz\_SISO\_NTNV\_90MHz\_CP-OFDM\_QPSK\_3934.98MHz\_Edge\_1RB\_Right\_Ant1

| Start (MHz) | Stop (MHz) | RBW (MHz) | Method | Marker No. | Freq (MHz) | Level (dBm) | Limit (dBm) | Result |
|---|---|---|---|---|---|---|---|---|
| 3884.98 | 3888.98 | 0.5 | CHP | 1 | 3888.070 | -43.65 | -13 | Pass |
| 3888.98 | 3889.98 | 0.03 | / | 2 | 3889.795 | -54.59 | -13 | Pass |
| 3979.98 | 3980.98 | 0.03 | / | 3 | 3980.000 | -35.06 | -13 | Pass |
| 3980.98 | 3984.98 | 0.5 | CHP | 4 | 3982.040 | -43.12 | -13 | Pass |

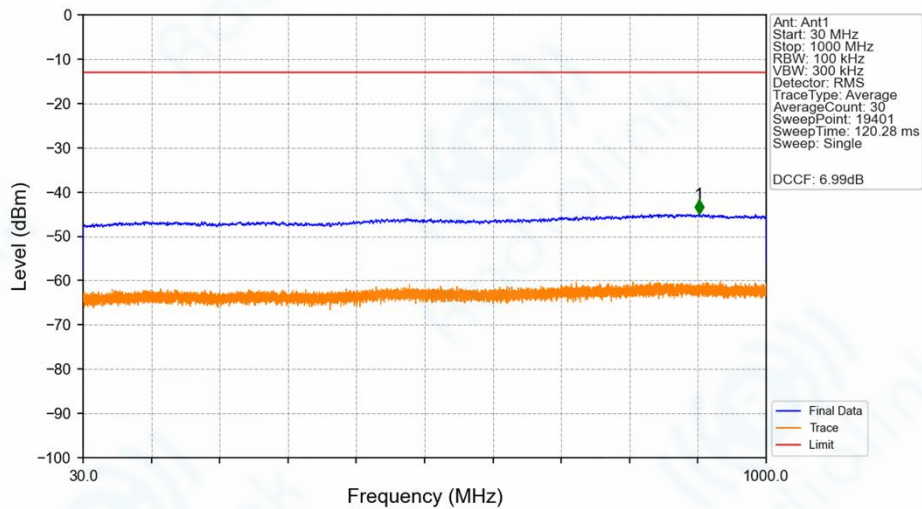
## n77a\_30kHz\_SISO\_NTNV\_90MHz\_CP-OFDM\_QPSK\_3934.98MHz\_Edge\_1RB\_Right\_Ant1

| Start (MHz) | Stop (MHz) | RBW (MHz) | Method | Marker No. | Freq (MHz) | Level (dBm) | Limit (dBm) | Result |
|---|---|---|---|---|---|---|---|---|
| 30 | 1000 | 1 | CHP | 1 | 904.450 | -44.93 | -13 | Pass |

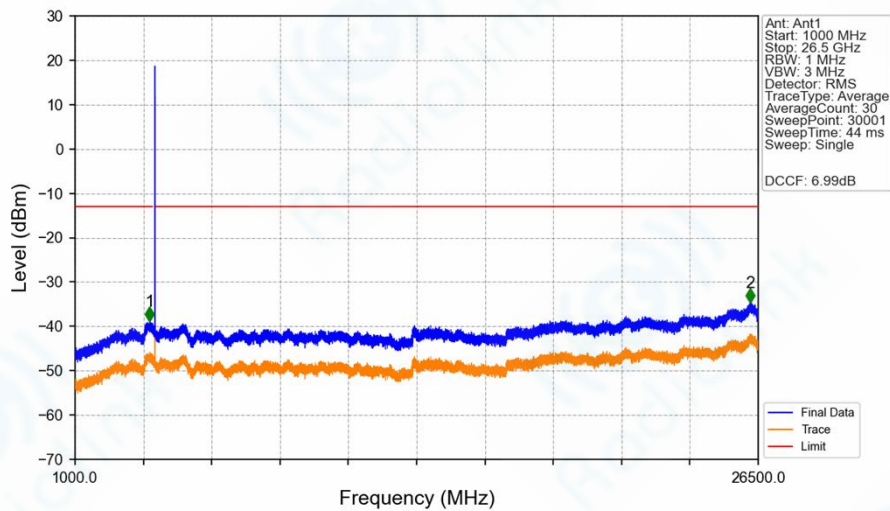
## n77a\_30kHz\_SISO\_NTNV\_90MHz\_CP-OFDM\_QPSK\_3934.98MHz\_Edge\_1RB\_Right\_Ant1

| Start (MHz) | Stop (MHz) | RBW (MHz) | Method | Marker No. | Freq (MHz) | Level (dBm) | Limit (dBm) | Result |
|---|---|---|---|---|---|---|---|---|
| 1000 | 3884.98 | 1 | / | 1 | 3788.000 | -38.84 | -13 | Pass |
| 3984.98 | 26500 | 1 | / | 2 | 26195.700 | -34.68 | -13 | Pass |

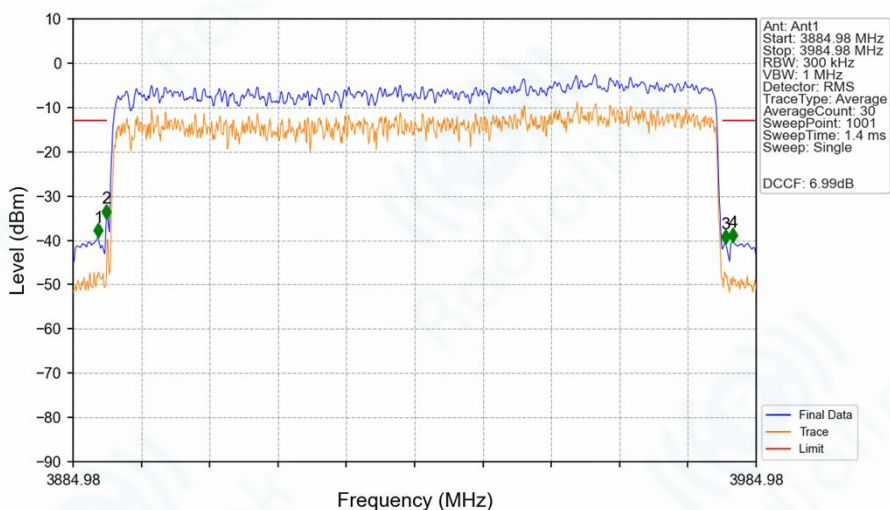
## n77a\_30kHz\_SISO\_NTNV\_90MHz\_CP-OFDM\_QPSK\_3934.98MHz\_Outer\_Full\_Ant1

| Start (MHz) | Stop (MHz) | RBW (MHz) | Method | Marker No. | Freq (MHz) | Level (dBm) | Limit (dBm) | Result |
|---|---|---|---|---|---|---|---|---|
| 3884.98 | 3888.98 | 0.5 | CHP | 1 | 3888.680 | -39.23 | -13 | Pass |
| 3888.98 | 3889.98 | 0.35 | CHP | 2 | 3889.880 | -35.03 | -13 | Pass |
| 3979.98 | 3980.98 | 0.35 | CHP | 3 | 3980.480 | -40.71 | -13 | Pass |
| 3980.98 | 3984.98 | 0.5 | CHP | 4 | 3981.580 | -40.45 | -13 | Pass |

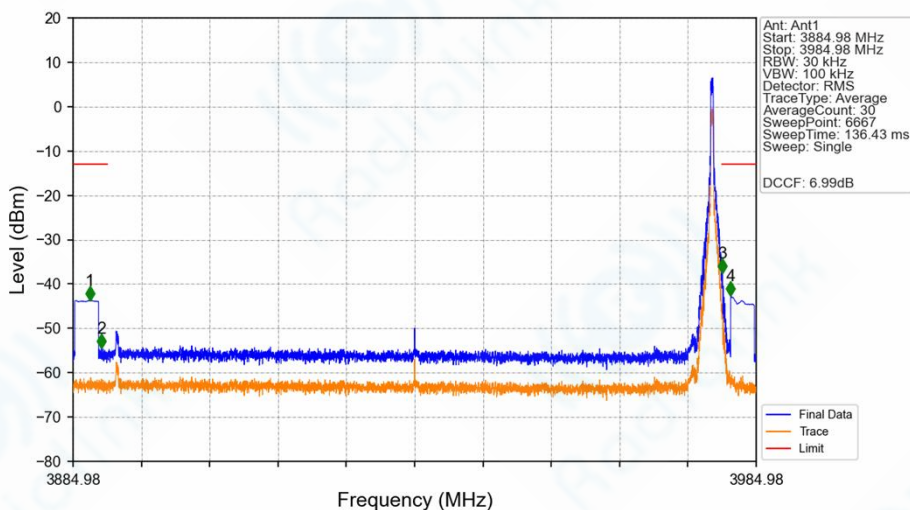
## n77a\_30kHz\_SISO\_NTNV\_90MHz\_CP-OFDM\_QPSK\_3934.98MHz\_Inner\_1RB\_Right\_Ant1

| Start (MHz) | Stop (MHz) | RBW (MHz) | Method | Marker No. | Freq (MHz) | Level (dBm) | Limit (dBm) | Result |
|---|---|---|---|---|---|---|---|---|
| 3884.98 | 3888.98 | 0.5 | CHP | 1 | 3887.440 | -43.69 | -13 | Pass |
| 3888.98 | 3889.98 | 0.03 | / | 2 | 3889.135 | -54.41 | -13 | Pass |
| 3979.98 | 3980.98 | 0.03 | / | 3 | 3980.015 | -37.49 | -13 | Pass |
| 3980.98 | 3984.98 | 0.5 | CHP | 4 | 3981.245 | -42.65 | -13 | Pass |

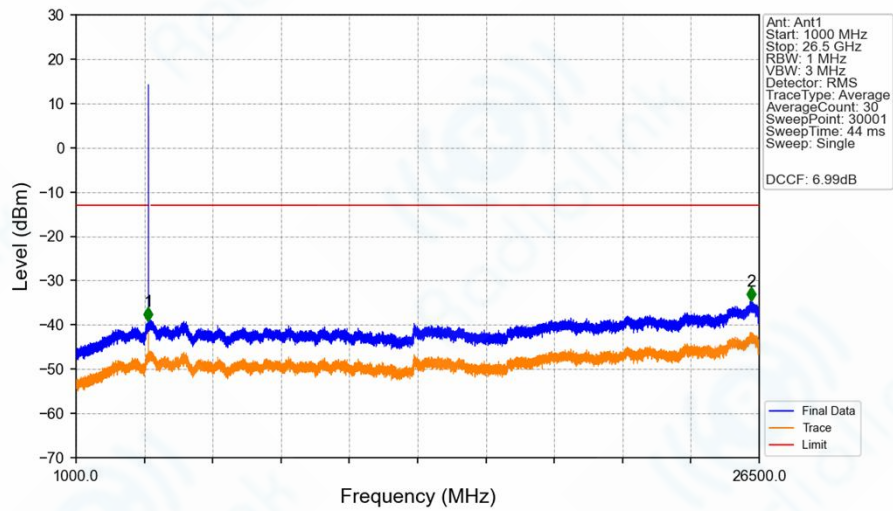
## n77a\_30kHz\_SISO\_NTNV\_100MHz\_DFT-s-OFDM\_PI/2\_BPSK\_3750MHz\_Edge\_1RB\_Left\_Ant1

| Start (MHz) | Stop (MHz) | RBW (MHz) | Method | Marker No. | Freq (MHz) | Level (dBm) | Limit (dBm) | Result |
|---|---|---|---|---|---|---|---|---|
| 1000 | 3695 | 1 | / | 1 | 3692.800 | -39.21 | -13 | Pass |
| 3805 | 26500 | 1 | / | 2 | 26190.600 | -34.67 | -13 | Pass |

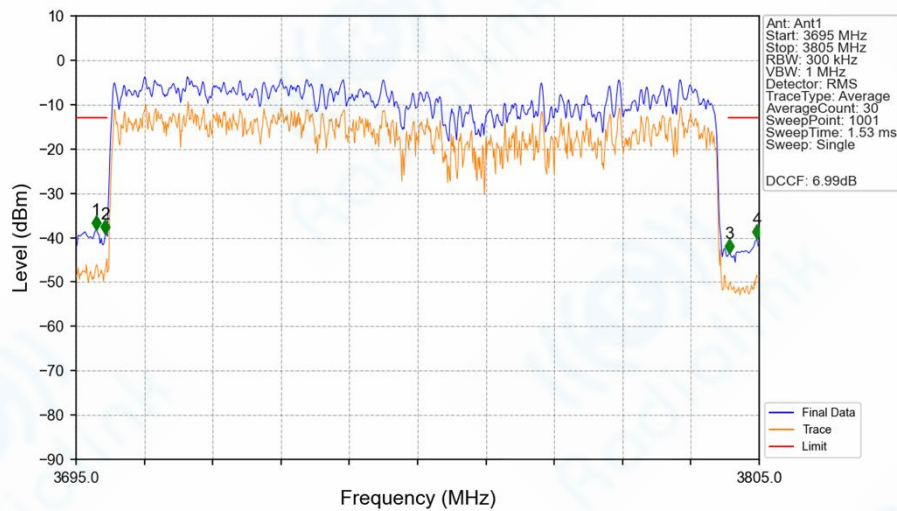
## n77a\_30kHz\_SISO\_NTNV\_100MHz\_DFT-s-OFDM\_PI/2\_BPSK\_3750MHz\_Outer\_Full\_Ant1

| Start (MHz) | Stop (MHz) | RBW (MHz) | Method | Marker No. | Freq (MHz) | Level (dBm) | Limit (dBm) | Result |
|---|---|---|---|---|---|---|---|---|
| 3695 | 3699 | 0.5 | CHP | 1 | 3698.190 | -38.29 | -13 | Pass |
| 3699 | 3700 | 0.35 | CHP | 2 | 3699.730 | -39.19 | -13 | Pass |
| 3800 | 3801 | 0.35 | CHP | 3 | 3800.160 | -43.46 | -13 | Pass |
| 3801 | 3805 | 0.5 | CHP | 4 | 3804.670 | -40.19 | -13 | Pass |

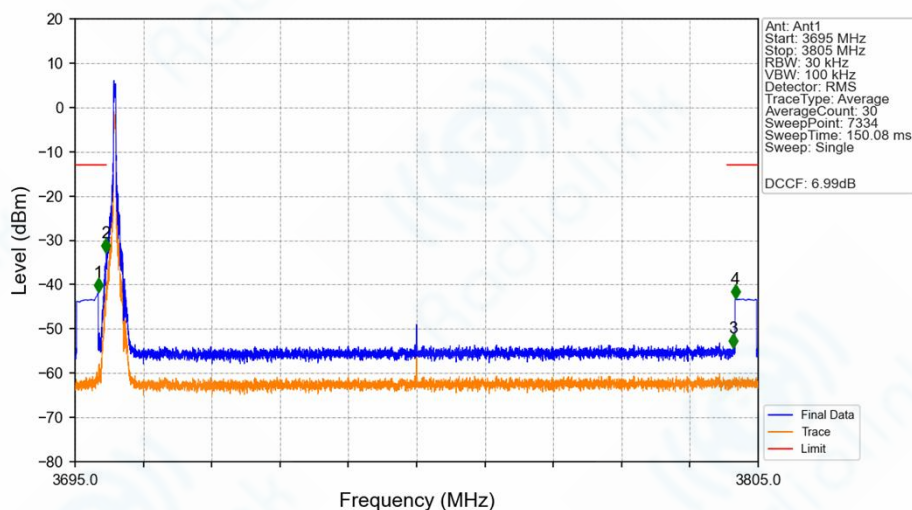
n77a\_30kHz\_SISO\_NTNV\_100MHz\_DFT-s-OFDM\_PI/2\_BPSK\_3750MHz\_Inner\_1RB\_Left\_Ant1

| Start (MHz) | Stop (MHz) | RBW (MHz) | Method | Marker No. | Freq (MHz) | Level (dBm) | Limit (dBm) | Result |
|---|---|---|---|---|---|---|---|---|
| 3695 | 3699 | 0.5 | CHP | 1 | 3698.735 | -41.74 | -13 | Pass |
| 3699 | 3700 | 0.03 | / | 2 | 3699.995 | -32.72 | -13 | Pass |
| 3800 | 3801 | 0.03 | / | 3 | 3800.905 | -54.25 | -13 | Pass |
| 3801 | 3805 | 0.5 | CHP | 4 | 3801.325 | -43.23 | -13 | Pass |

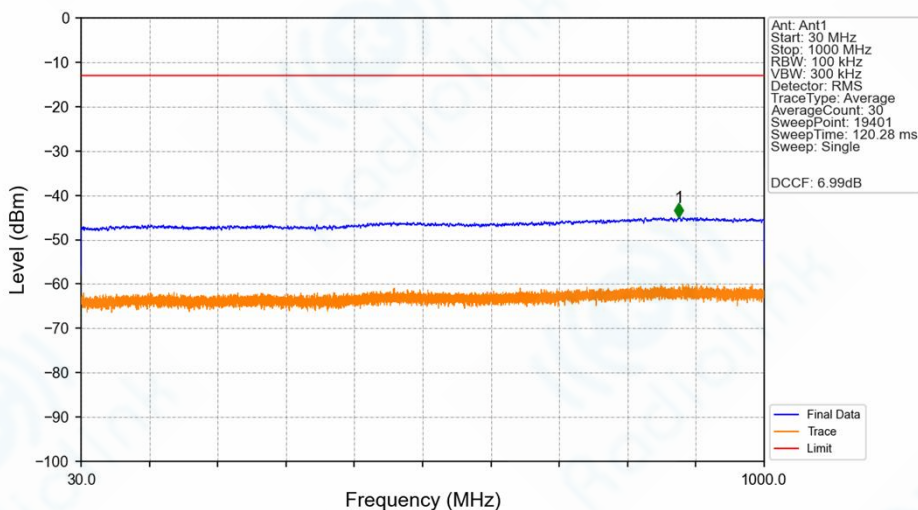
n77a\_30kHz\_SISO\_NTNV\_100MHz\_DFT-s-OFDM\_PI/2\_BPSK\_3840MHz\_Edge\_1RB\_Left\_Ant1

| Start (MHz) | Stop (MHz) | RBW (MHz) | Method | Marker No. | Freq (MHz) | Level (dBm) | Limit (dBm) | Result |
|---|---|---|---|---|---|---|---|---|
| 30 | 1000 | 1 | CHP | 1 | 878.550 | -44.90 | -13 | Pass |

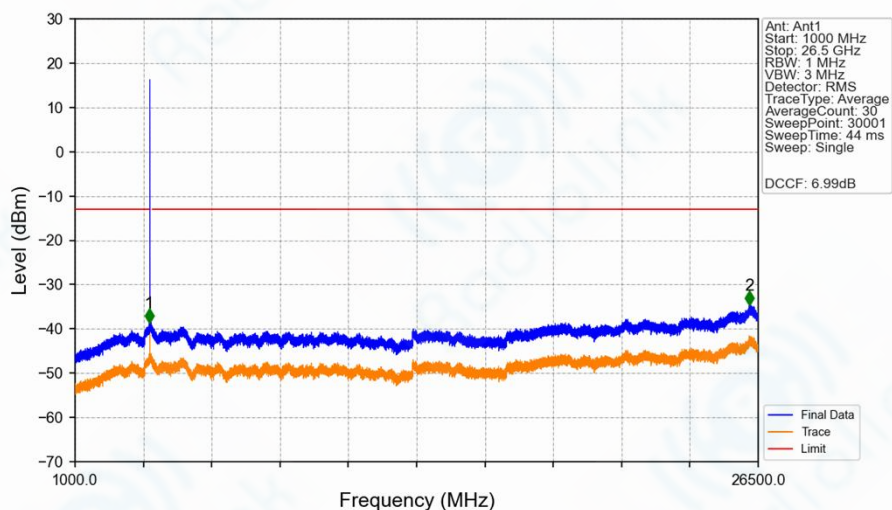
## n77a\_30kHz\_SISO\_NTNV\_100MHz\_DFT-s-OFDM\_PI/2\_BPSK\_3840MHz\_Edge\_1RB\_Left\_Ant1

| Start (MHz) | Stop (MHz) | RBW (MHz) | Method | Marker No. | Freq (MHz) | Level (dBm) | Limit (dBm) | Result |
|---|---|---|---|---|---|---|---|---|
| 1000 | 3785 | 1 | / | 1 | 3766.750 | -38.64 | -13 | Pass |
| 3895 | 26500 | 1 | / | 2 | 26165.950 | -34.56 | -13 | Pass |

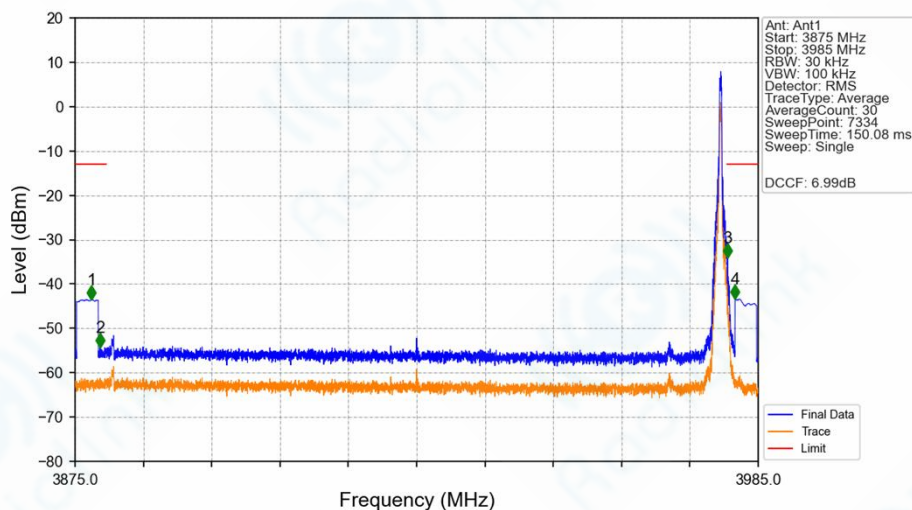
## n77a\_30kHz\_SISO\_NTNV\_100MHz\_DFT-s-OFDM\_PI/2\_BPSK\_3930MHz\_Edge\_1RB\_Right\_Ant1

| Start (MHz) | Stop (MHz) | RBW (MHz) | Method | Marker No. | Freq (MHz) | Level (dBm) | Limit (dBm) | Result |
|---|---|---|---|---|---|---|---|---|
| 3875 | 3879 | 0.5 | CHP | 1 | 3877.640 | -43.47 | -13 | Pass |
| 3879 | 3880 | 0.03 | / | 2 | 3879.095 | -54.23 | -13 | Pass |
| 3980 | 3981 | 0.03 | / | 3 | 3980.095 | -34.03 | -13 | Pass |
| 3981 | 3985 | 0.5 | CHP | 4 | 3981.265 | -43.25 | -13 | Pass |

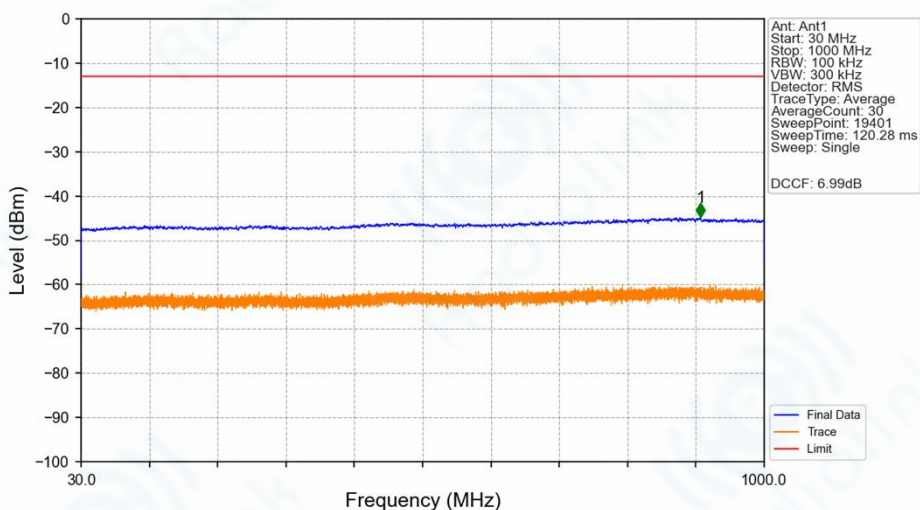
## n77a\_30kHz\_SISO\_NTNV\_100MHz\_DFT-s-OFDM PI/2 BPSK\_3930MHz\_Edge\_1RB\_Right\_Ant1

| Start (MHz) | Stop (MHz) | RBW (MHz) | Method | Marker No. | Freq (MHz) | Level (dBm) | Limit (dBm) | Result |
|---|---|---|---|---|---|---|---|---|
| 30 | 1000 | 1 | CHP | 1 | 909.800 | -44.79 | -13 | Pass |

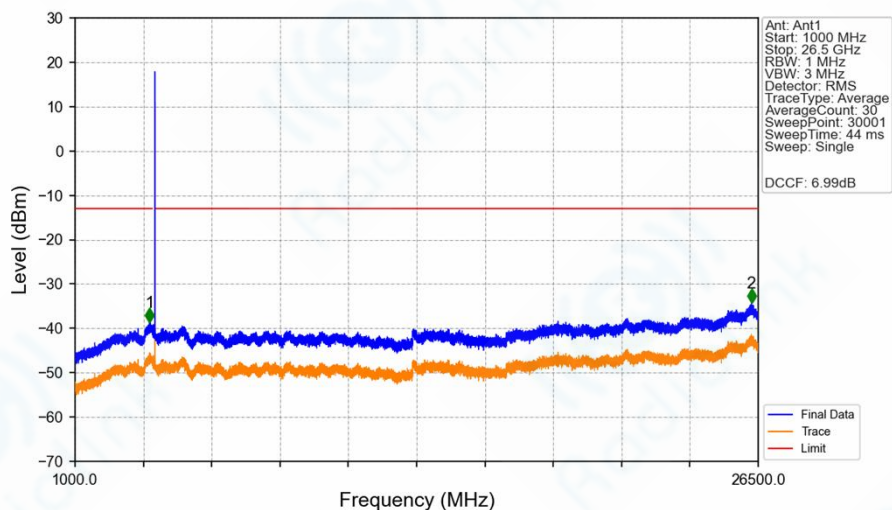
## n77a\_30kHz\_SISO\_NTNV\_100MHz\_DFT-s-OFDM PI/2 BPSK\_3930MHz\_Edge\_1RB\_Right\_Ant1

| Start (MHz) | Stop (MHz) | RBW (MHz) | Method | Marker No. | Freq (MHz) | Level (dBm) | Limit (dBm) | Result |
|---|---|---|---|---|---|---|---|---|
| 1000 | 3875 | 1 | / | 1 | 3778.650 | -38.53 | -13 | Pass |
| 3985 | 26500 | 1 | / | 2 | 26245.850 | -34.32 | -13 | Pass |

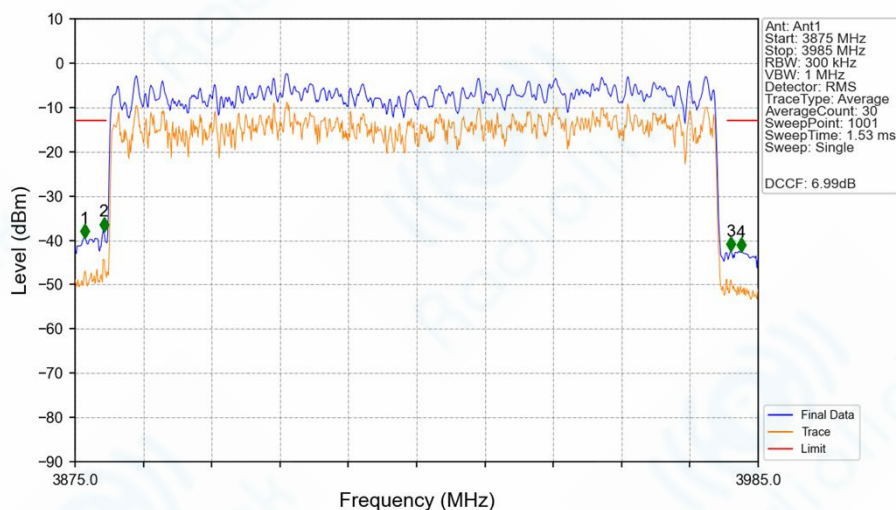
## n77a\_30kHz\_SISO\_NTNV\_100MHz\_DFT-s-OFDM\_PI/2\_BPSK\_3930MHz\_Outer\_Full\_Ant1

| Start (MHz) | Stop (MHz) | RBW (MHz) | Method | Marker No. | Freq (MHz) | Level (dBm) | Limit (dBm) | Result |
|---|---|---|---|---|---|---|---|---|
| 3875 | 3879 | 0.5 | CHP | 1 | 3876.540 | -39.50 | -13 | Pass |
| 3879 | 3880 | 0.35 | CHP | 2 | 3879.620 | -37.94 | -13 | Pass |
| 3980 | 3981 | 0.35 | CHP | 3 | 3980.600 | -42.43 | -13 | Pass |
| 3981 | 3985 | 0.5 | CHP | 4 | 3982.250 | -42.53 | -13 | Pass |

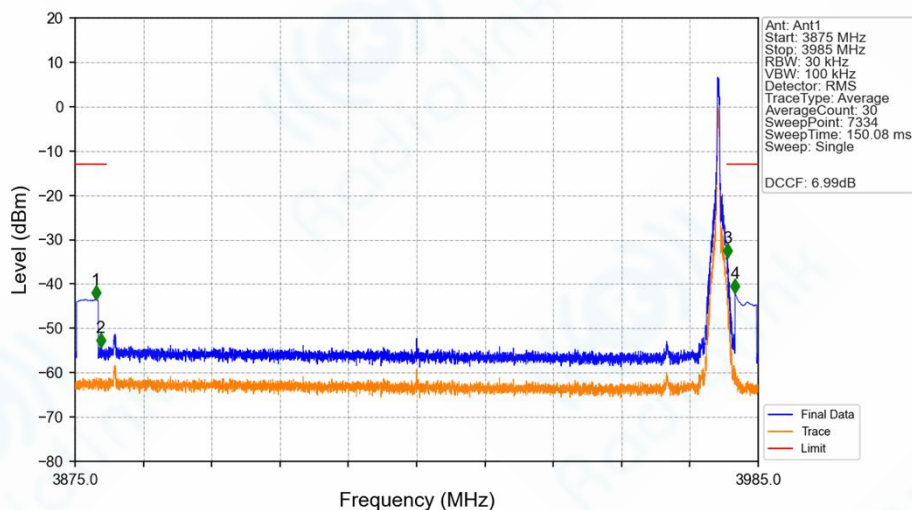
## n77a\_30kHz\_SISO\_NTNV\_100MHz\_DFT-s-OFDM\_PI/2\_BPSK\_3930MHz\_Inner\_1RB\_Right\_Ant1

| Start (MHz) | Stop (MHz) | RBW (MHz) | Method | Marker No. | Freq (MHz) | Level (dBm) | Limit (dBm) | Result |
|---|---|---|---|---|---|---|---|---|
| 3875 | 3879 | 0.5 | CHP | 1 | 3878.345 | -43.46 | -13 | Pass |
| 3879 | 3880 | 0.03 | / | 2 | 3879.110 | -54.32 | -13 | Pass |
| 3980 | 3981 | 0.03 | / | 3 | 3980.035 | -34.09 | -13 | Pass |
| 3981 | 3985 | 0.5 | CHP | 4 | 3981.265 | -42.11 | -13 | Pass |

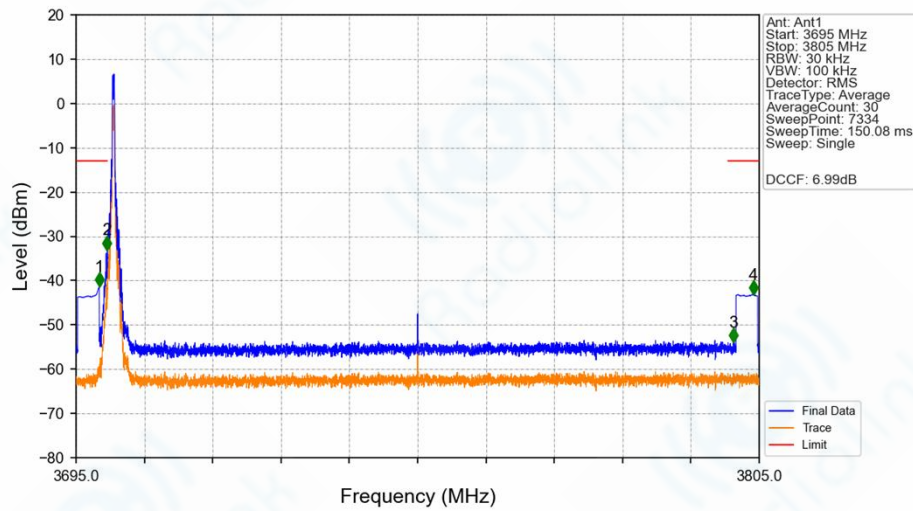
n77a\_30kHz\_SISO\_NTNV\_100MHz\_DFT-s-OFDM\_QPSK\_3750MHz\_Edge\_1RB\_Left\_Ant1

| Start (MHz) | Stop (MHz) | RBW (MHz) | Method | Marker No. | Freq (MHz) | Level (dBm) | Limit (dBm) | Result |
|---|---|---|---|---|---|---|---|---|
| 3695 | 3699 | 0.5 | CHP | 1 | 3698.735 | -41.34 | -13 | Pass |
| 3699 | 3700 | 0.03 | / | 2 | 3699.995 | -33.05 | -13 | Pass |
| 3800 | 3801 | 0.03 | / | 3 | 3800.845 | -53.93 | -13 | Pass |
| 3801 | 3805 | 0.5 | CHP | 4 | 3804.085 | -43.10 | -13 | Pass |

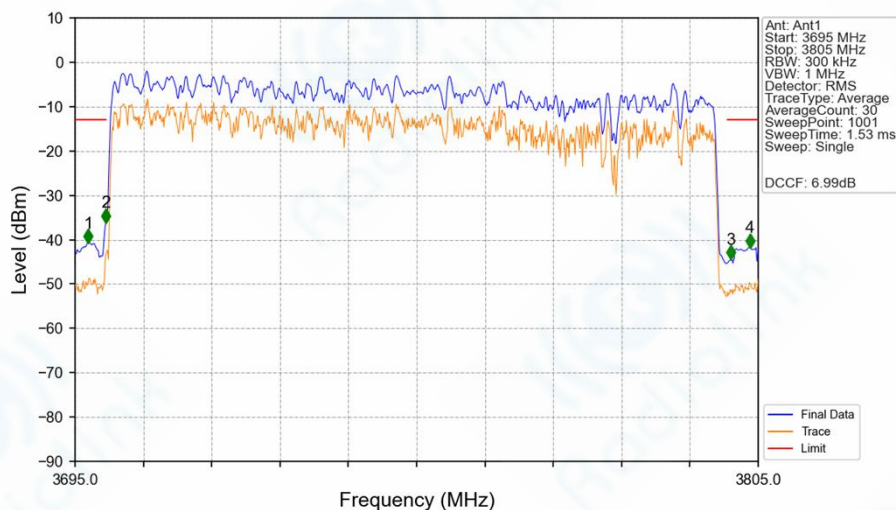
## n77a\_30kHz\_SISO\_NTNV\_100MHz\_DFT-s-OFDM\_QPSK\_3750MHz\_Outer\_Full\_Ant1

| Start (MHz) | Stop (MHz) | RBW (MHz) | Method | Marker No. | Freq (MHz) | Level (dBm) | Limit (dBm) | Result |
|---|---|---|---|---|---|---|---|---|
| 3695 | 3699 | 0.5 | CHP | 1 | 3697.090 | -40.69 | -13 | Pass |
| 3699 | 3700 | 0.35 | CHP | 2 | 3699.950 | -36.12 | -13 | Pass |
| 3800 | 3801 | 0.35 | CHP | 3 | 3800.600 | -44.46 | -13 | Pass |
| 3801 | 3805 | 0.5 | CHP | 4 | 3803.680 | -41.77 | -13 | Pass |

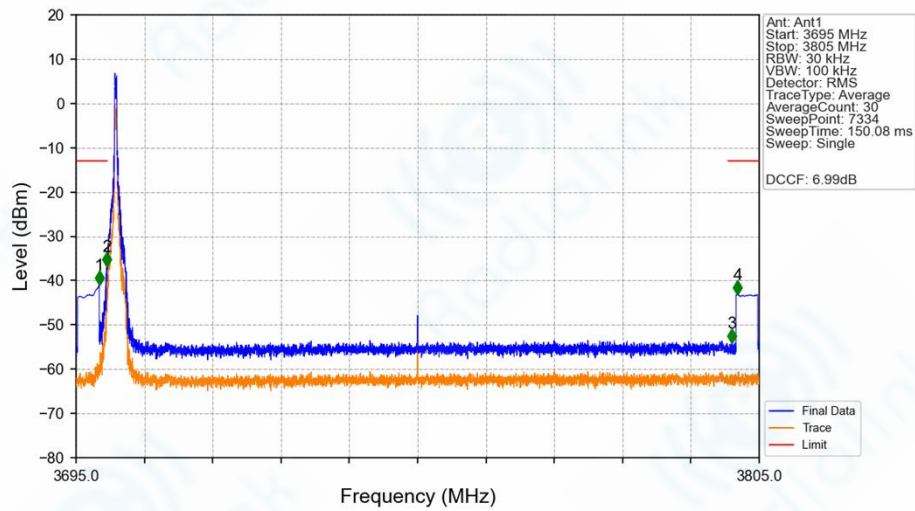
## n77a\_30kHz\_SISO\_NTNV\_100MHz\_DFT-s-OFDM\_QPSK\_3750MHz\_Inner\_1RB\_Left\_Ant1

| Start (MHz) | Stop (MHz) | RBW (MHz) | Method | Marker No. | Freq (MHz) | Level (dBm) | Limit (dBm) | Result |
|---|---|---|---|---|---|---|---|---|
| 3695 | 3699 | 0.5 | CHP | 1 | 3698.735 | -40.94 | -13 | Pass |
| 3699 | 3700 | 0.03 | / | 2 | 3699.950 | -36.81 | -13 | Pass |
| 3800 | 3801 | 0.03 | / | 3 | 3800.590 | -54.14 | -13 | Pass |
| 3801 | 3805 | 0.5 | CHP | 4 | 3801.505 | -43.14 | -13 | Pass |

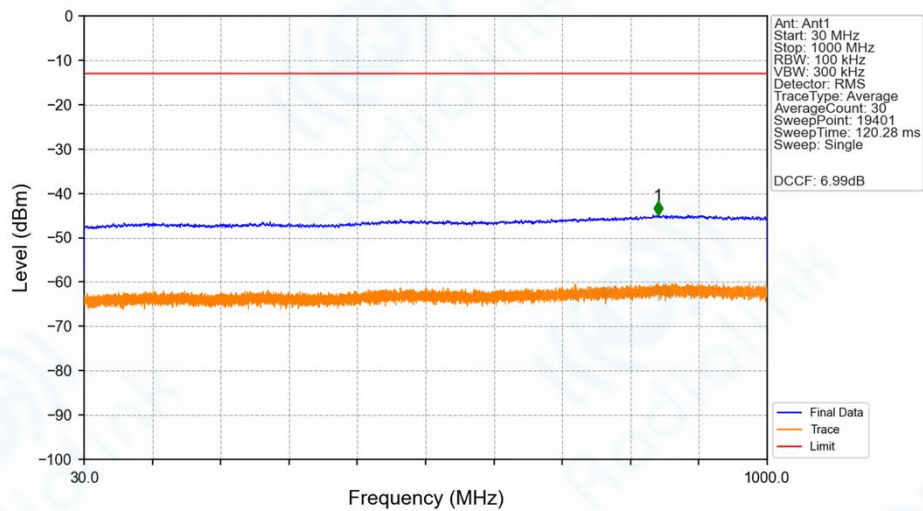
## n77a\_30kHz\_SISO\_NTNV\_100MHz\_DFT-s-OFDM\_QPSK\_3840MHz\_Edge\_1RB\_Left\_Ant1

| Start (MHz) | Stop (MHz) | RBW (MHz) | Method | Marker No. | Freq (MHz) | Level (dBm) | Limit (dBm) | Result |
|---|---|---|---|---|---|---|---|---|
| 30 | 1000 | 1 | CHP | 1 | 844.900 | -44.88 | -13 | Pass |
